ADVANCED HOME INSPECTIONS

SAMPLE Inspection Report For:

77777 Home Inspector Lane

PROPERTY INSPECTION REPORT

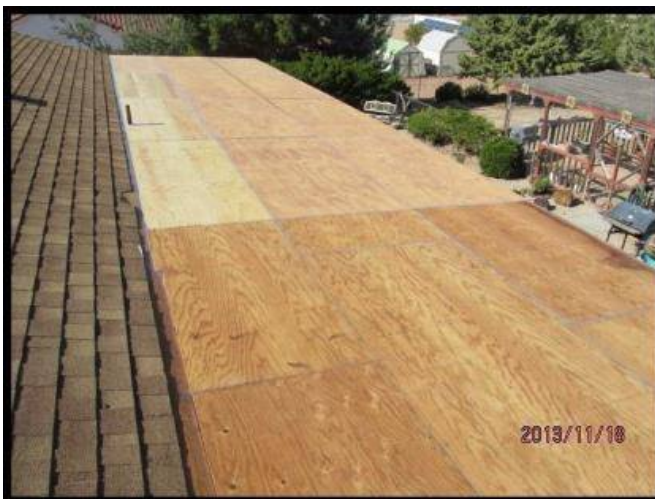
Further Review: The patio cover roofing materials were missing or not yet installed. We recommend further evaluation with cost estimates for a clear understanding of the roof condition.

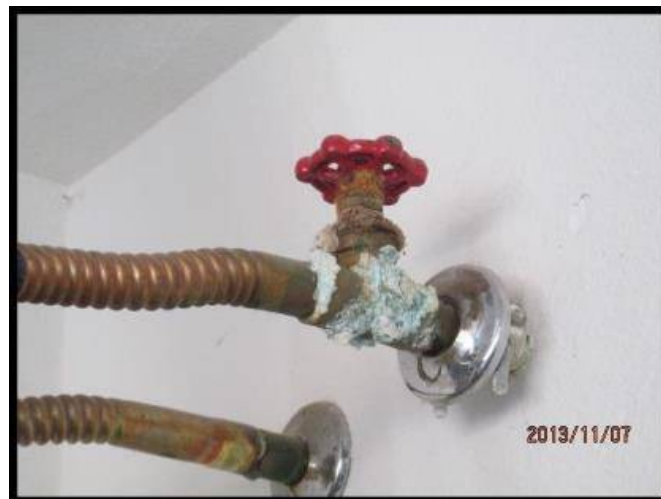
Water Connections

Repair: The water shut off valve at the water heater was observed to be corroded (non-visible leak that leaves mineral deposits) and visible leakage may occur with time. This valve should be repaired or replaced as required.

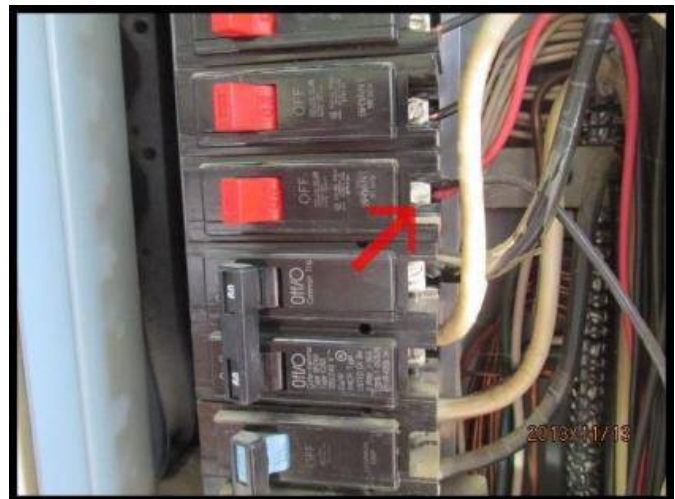
Repair: More than one wire was installed at a breaker which was designed for the installation of only one wire. This "double tapping" cannot ensure that both wires, installed under a screw designed to carry only one wire, receive the same amount of pressure from the screw. Because positive connection for all the wires under the screw may not be the same there is a possibility of arcing. This arcing can result in dangerous resistance and heat buildup within the circuit, and is considered an improper electrical trade practice. We recommend the elimination of all double tapping by an appropriate person.

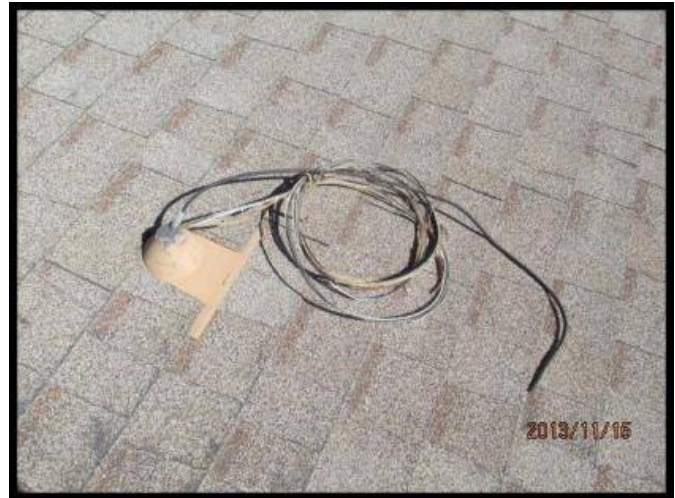
Rooftop Electrical

Safety Concern: Unterminated live wires were observed on the roof. This is a safety aspect of the building's electrical system and we recommend immediate repair. (This is a typical condition when a building is pre-wired for a separate evaporative cooler as an upgrade to the existing cooling system but not installed. If the circuit breaker is installed and energized for the evaporative cooler circuit you have this condition.)
